## Modernized 5F6-A Martin Manning November 2012

## Modernized 5F6-A Circuit Board Layout

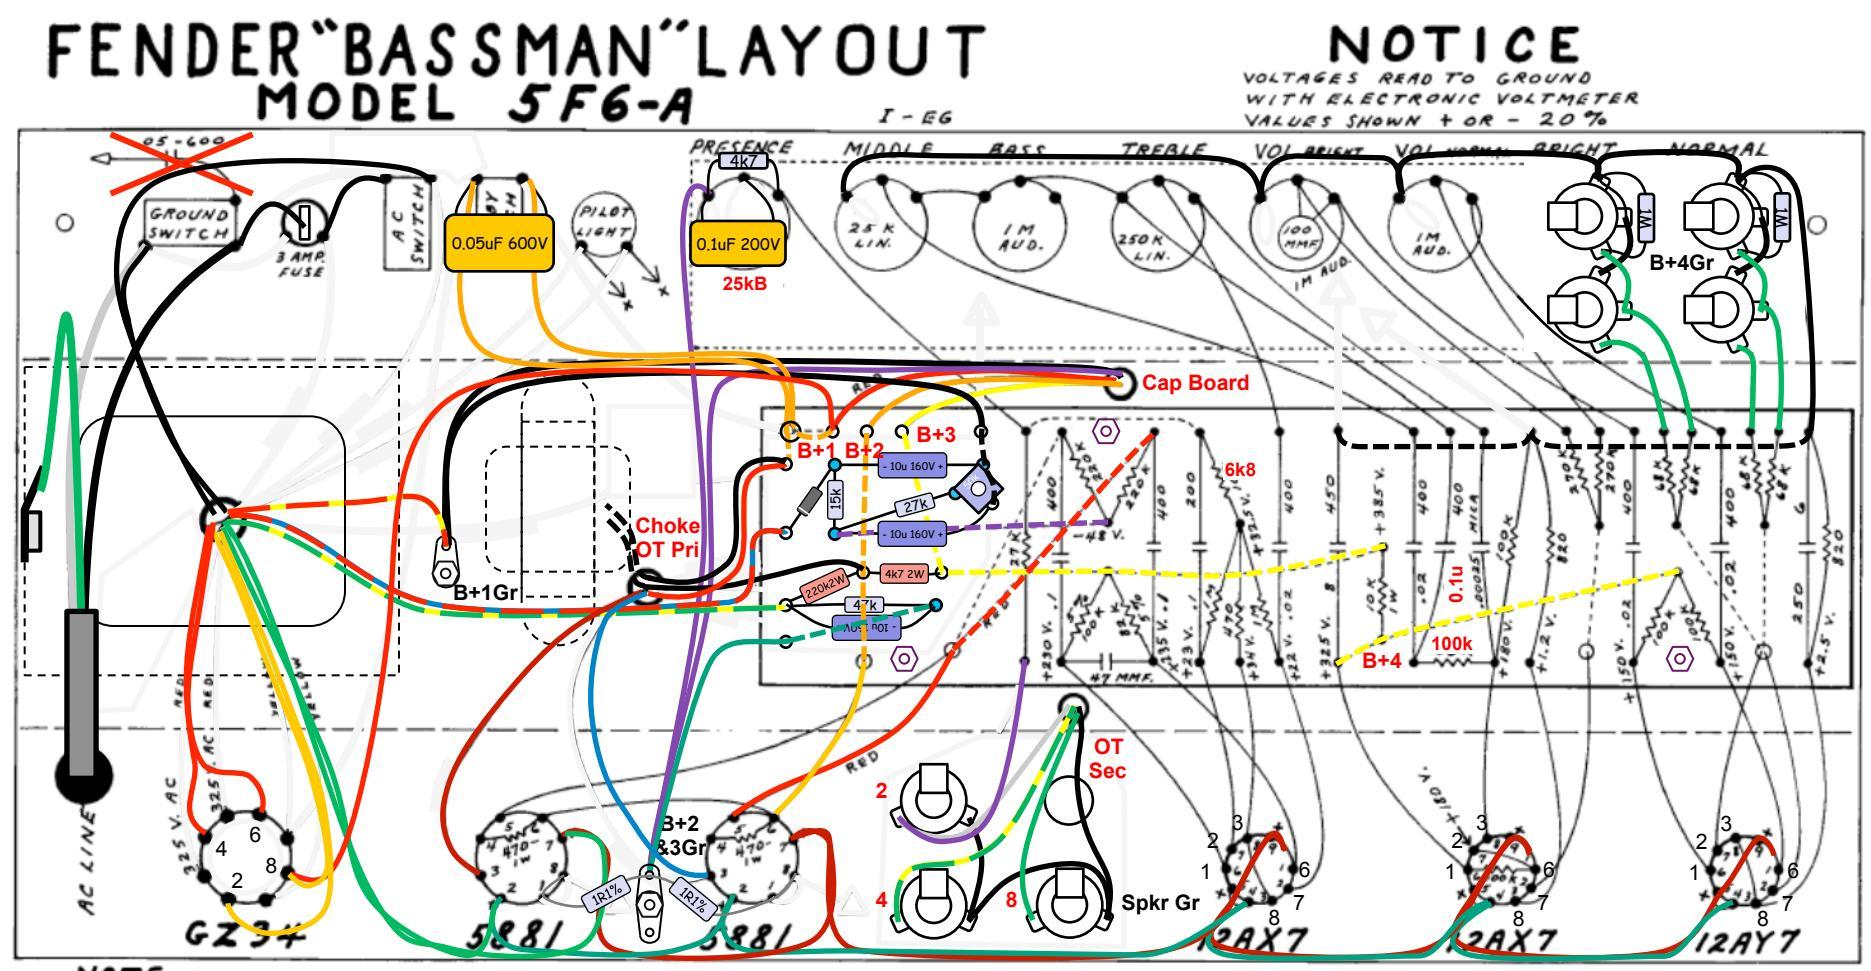
1) 3-wire power cord with earth ground attached at dedicated point on left side of chassis. 2) Ground switch is made non-functional by removal of 0.05 capacitor to ground. Switch is retained for cosmetic reasons and used as terminal for AC power line and neutral. 3) Line fuse located before power switch and on line side of power transformer 4) Preamp grounds routed to input jacks. 5) Power supply reservoir ground (black wire from cap board), HT winding center tap, and bias supply are grounded at B+1Gr. 6) B+2 and 3 filter grounds (purple wire from cap board) and phase inverter ground routed to power tube sockets. 7) Power tube cathodes grounded through 1-ohm resistors for idle current measurement. 8) Selenium rectifier replaced with 1N4007 silicon diode. 9) Bias voltage made adjustable by addition of trimmer pot. 10) Standby switch wired between reservoir capacitor and choke for soft-start of rectifier-reservoir. 11) 0.05uF capacitor from standby switch to ground is relocated across standby switch (or may be removed). 12) Heater supply center tap elevated using divider from B+2 node. 13) Changes to tone stack and PI tail component values (shown in red) reflect those seen in1959 5F6-A production examples and Fender "Reissue" '59 Bassman amp. 14) Preamp tube sockets are installed with pins 1 and 9 at the rear of the chassis to allow 1 cross-socket filament wiring. 15) Speaker output jacks shown for multi-tap OT secondary. Modern 5F6-A

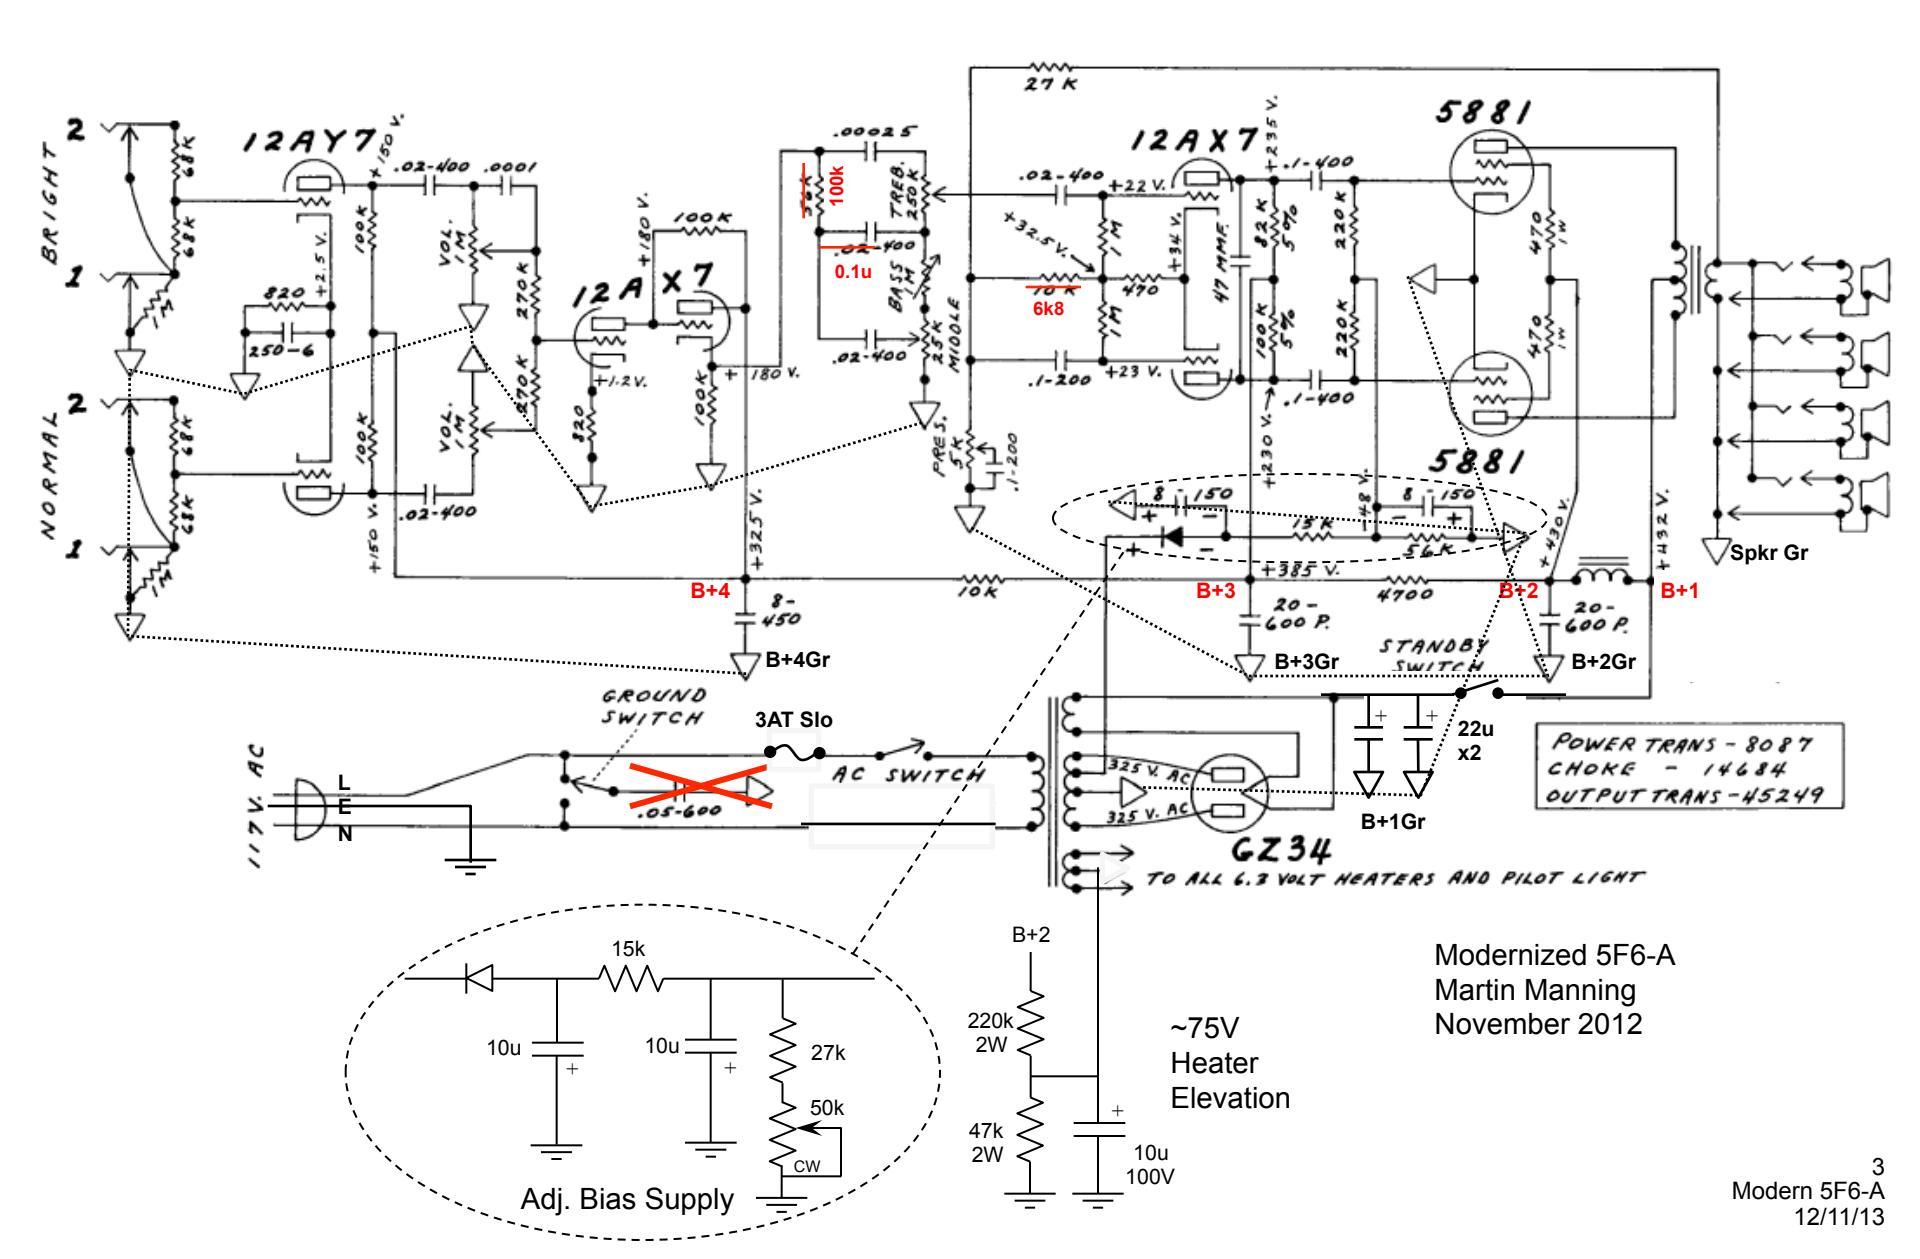
## FENDER "BASSMAN" SCHEMATIC MODEL 5F6-A

VOLTAGES READ TO GROUND WITH ELECTRONIC VOLTMETER VALUES SHOWN + OR - 20 %
